# **Facts and Lessons of the Fukushima Nuclear Accident and Safety Improvement -The Operator Viewpoints-**

September 19, 2012

DOE Nuclear Safety Workshop, @Bethesda, Maryland

Tokyo Electric Power Company

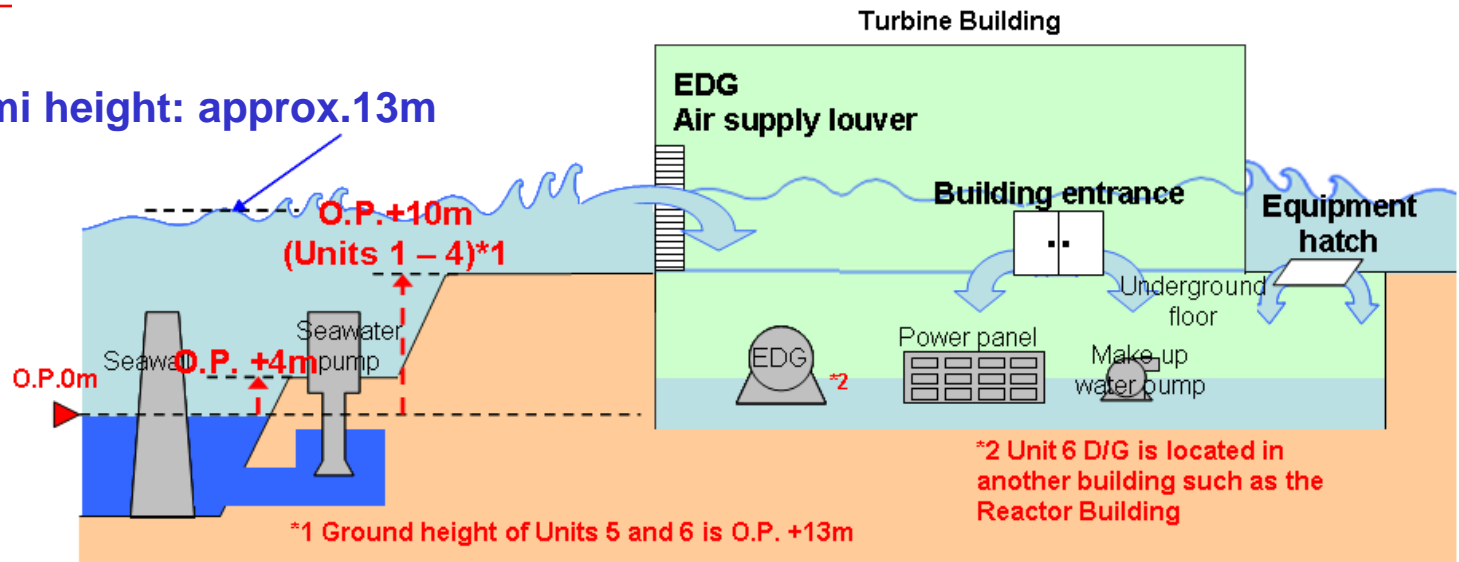
1F

Tsunami height: approx.13m

Design Basis  
Tsunami height:  
O.P.+6.1 m

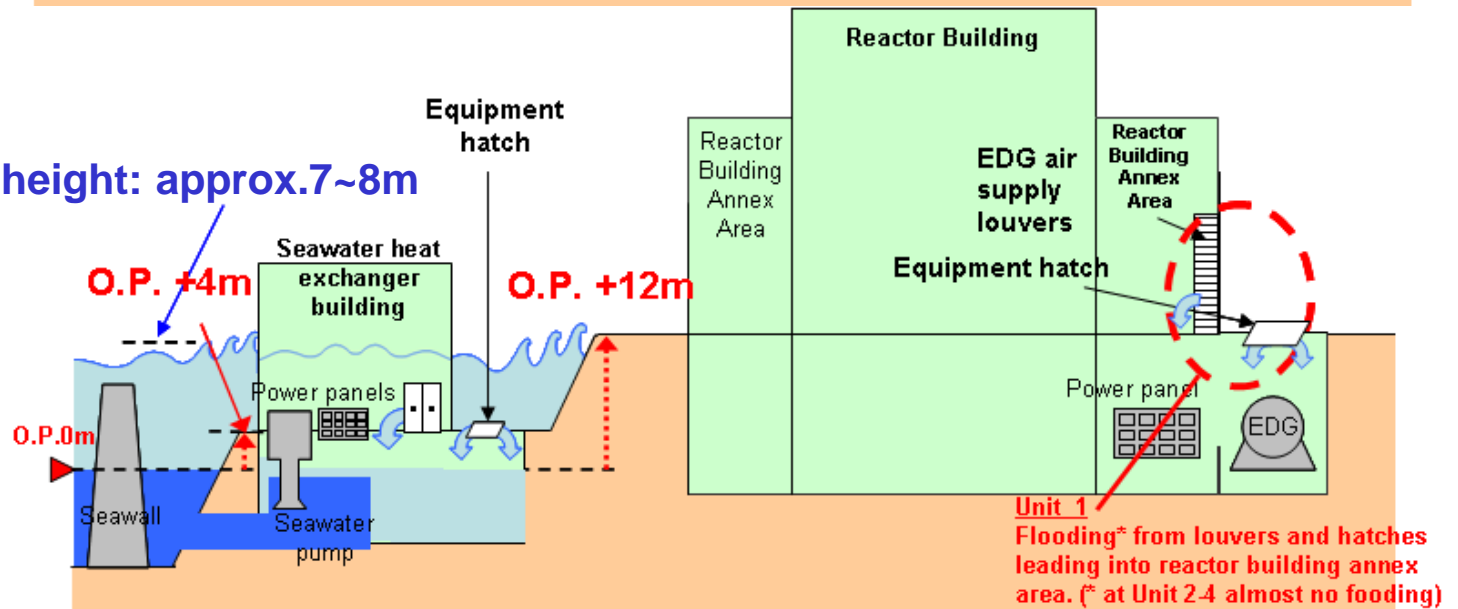
2F

Tsunami height: approx.7~8m

Design Basis  
Tsunami height:  
O.P.+5.2 m

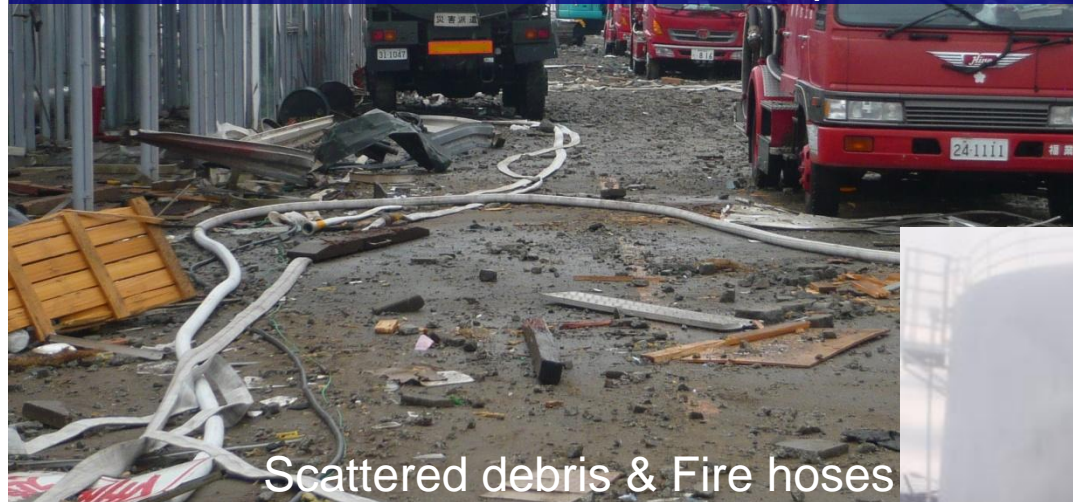
Scattered debris & Fire hoses

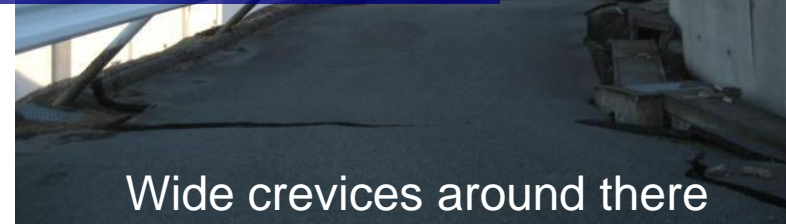
Wide crevices around there

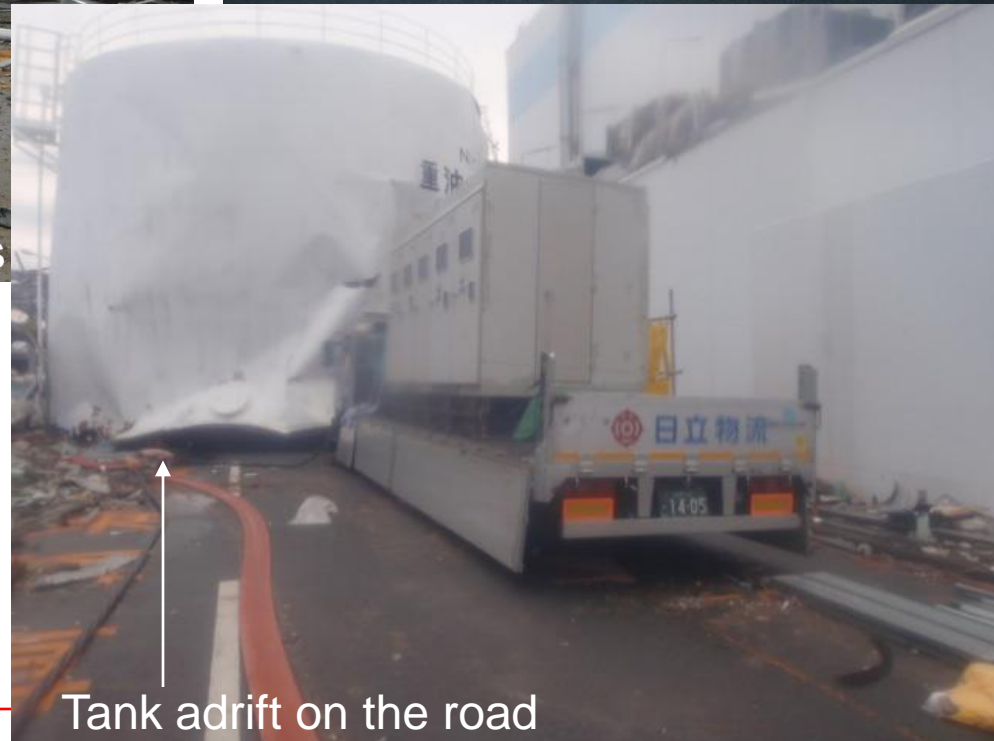
Tank adrift on the road

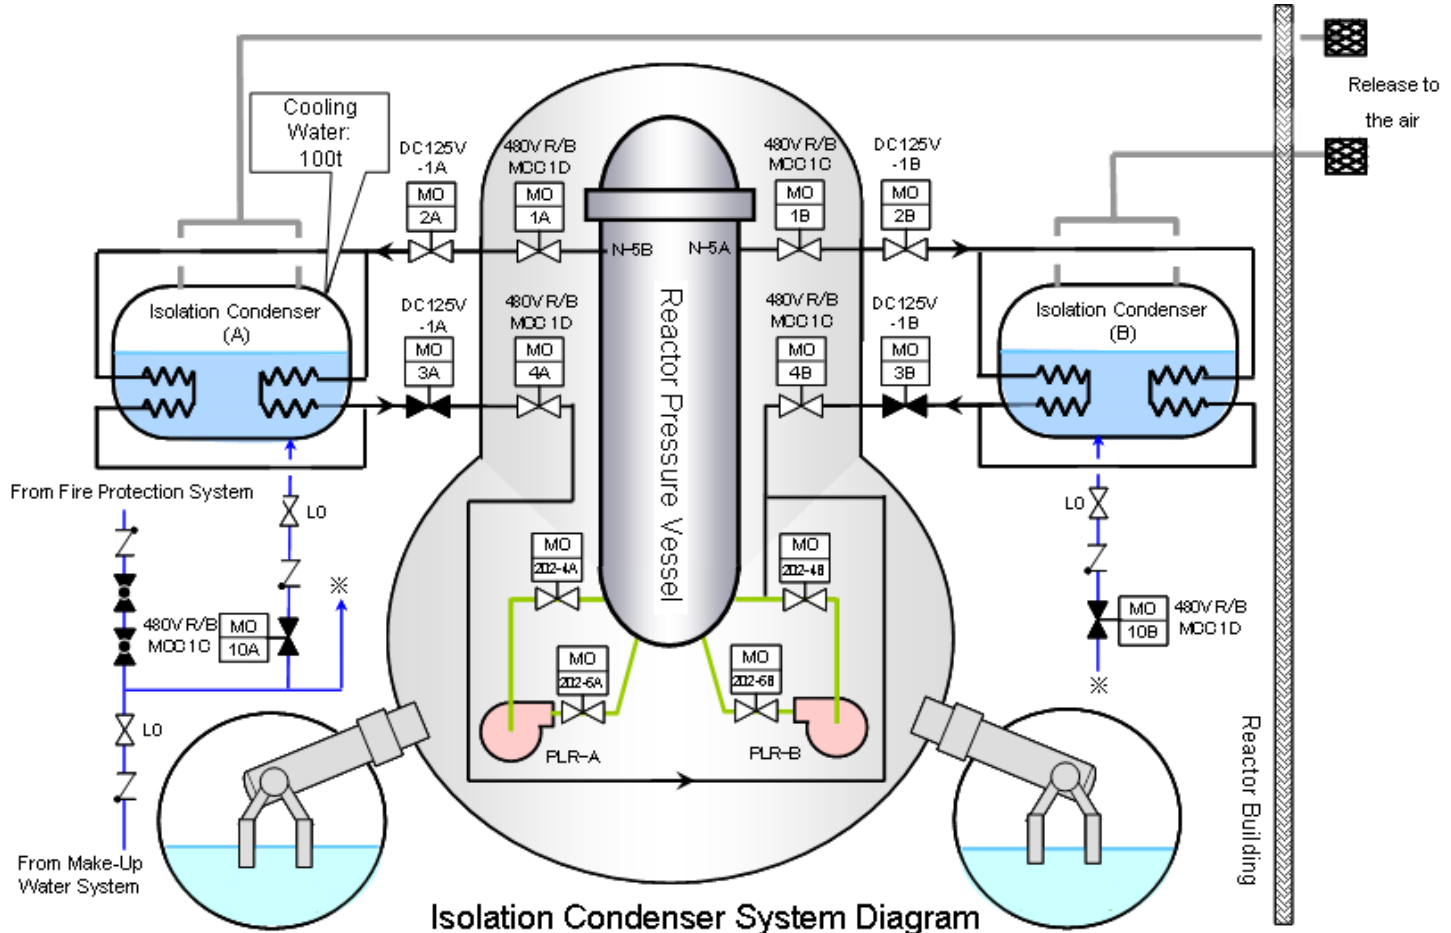
# Configuration of U1 Isolation Condenser

It is considered that core damage had progressed in a short period of time after the tsunami. Hence, the status of the IC, which is used to cool the reactor in the initial stages after shutdown, might have affected the event progression.

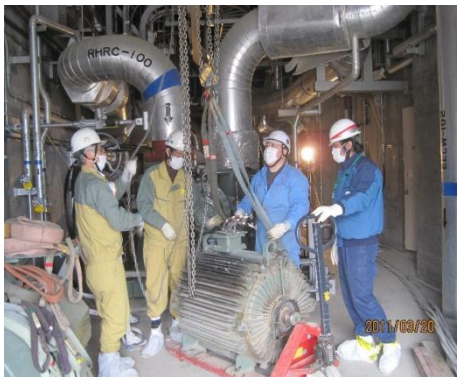
Motor replacement

- Pumps of RHR cooling systems (RHRC, RHRS, EECW) were inspected.
- Motors were replaced for pumps in RHRC and EECW.
- In order to restore the inundated electrical buses, temporary cable and high voltage mobile power vehicles were deployed.
- Temporary cable was laid from survived power cubicles in Rad-Waste Building and Unit 3 Heat Exchanger Building.
